Water Treatment Plant Filter Media City of Cooper, Texas

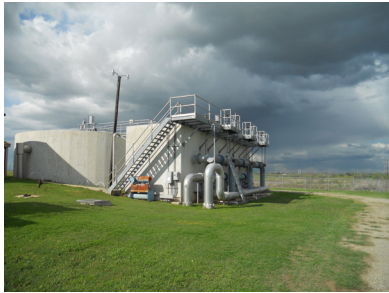
This project was undertaken in response to concerns about the water treatment plant's ability to meet water demand in the summer months of 2012. The filter media in the three north filter cells were experiencing shorter filter runs, as well as a situation called "growing media" — a condition that is normally associated with inadequate backwash capabilities and/or problems with chemical fouling of the media. The growing media could have resulted in the inability to produce enough water to meet high demand in the summer months.

Therefore, Filter Cell #7 was rehabilitated. The photo on the left shows the extreme build-up of chemical hardness on the inlet pipe and the backwash trough, and the photo next to it shows the total lack of build-up after rehabilitation.

The chemical fouling of the filter underdrains and the filter media was also removed. This allowed the filter production rate to increase back to original levels.
